Similkameen (Squantl) Falls

Rick Gillespie photos (Dec 2011)

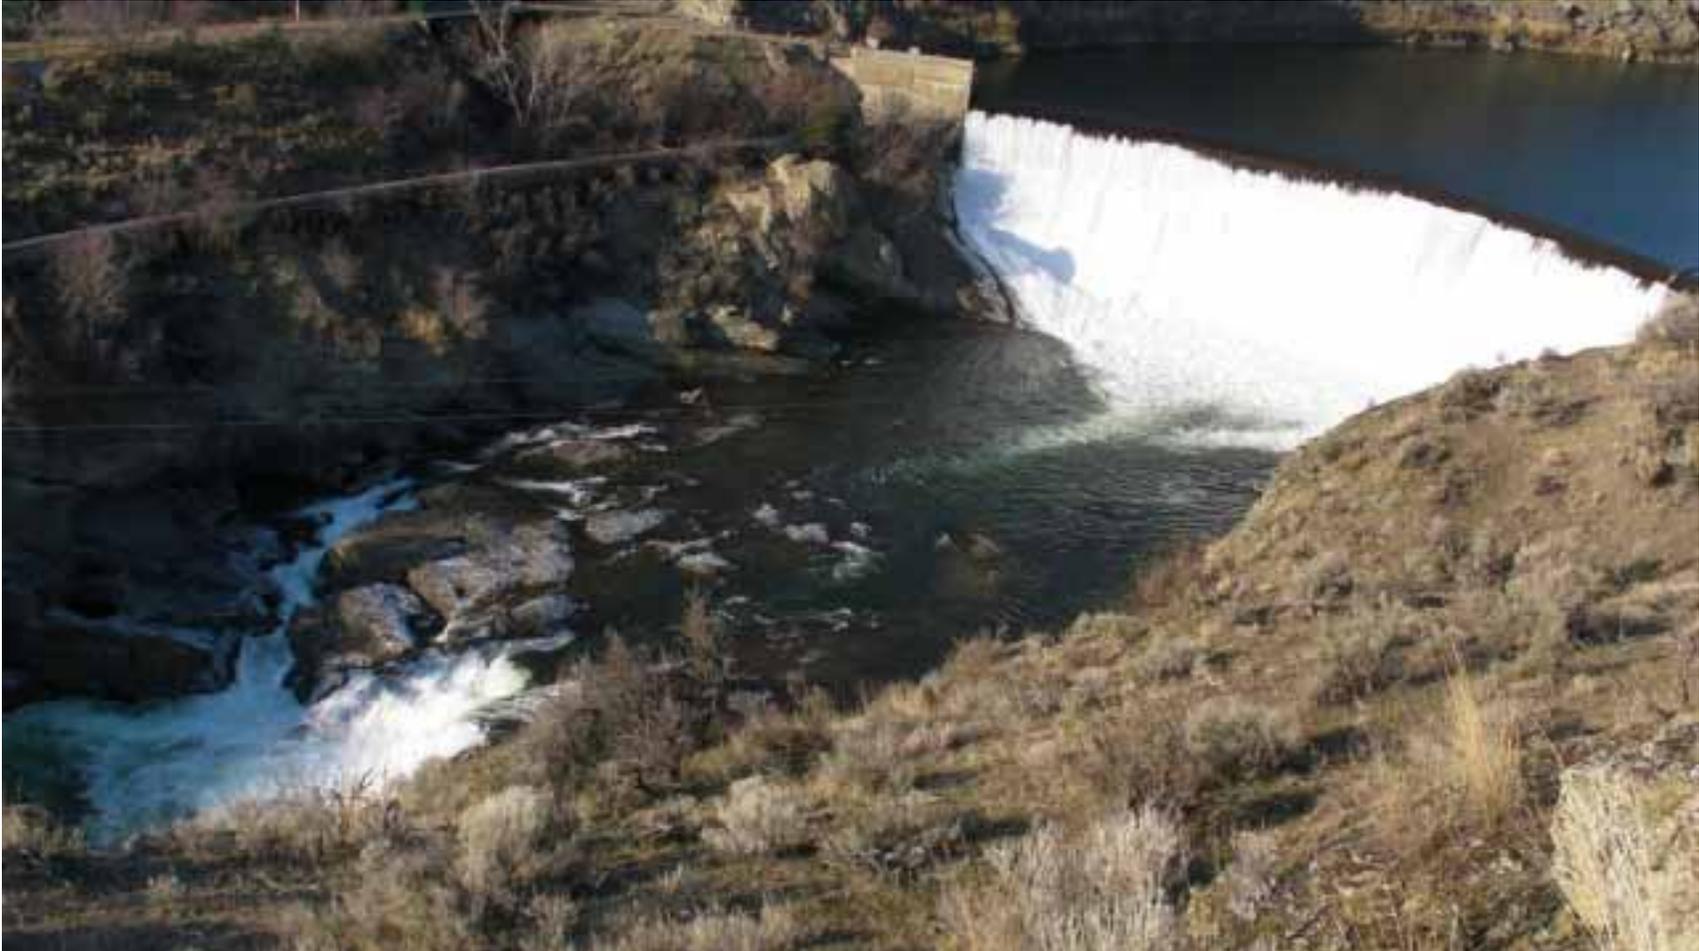
Showing the relationship of the Similkameen Falls to Enloe Dam up stream. Notice the natural channel on the west side of the main falls rock wall which may be a natural route up over the falls to gain access to the pool below Enloe Dam. If the dam were removed, it seems as though passage over the falls would not be the barrier for salmonids to the upper Similkameen River breeding habitats.

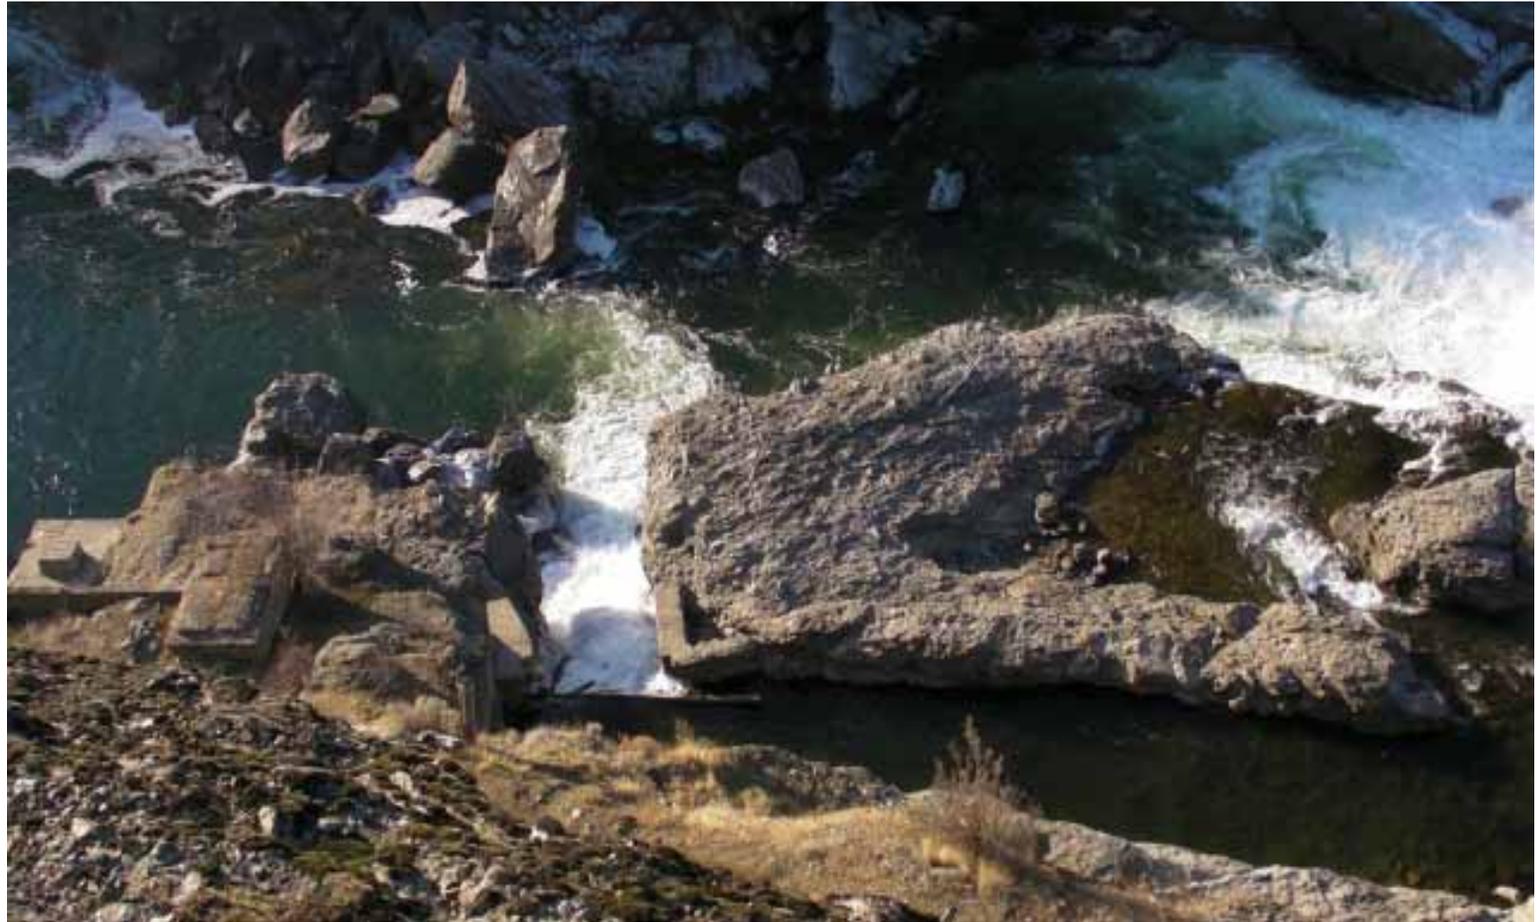
From above the falls looking on the west side of the falls with the main part of the falls in the middle of the picture.

This December flow is probably close to the low flow of the river.

Notice the natural channel on the west side of the falls which when covered with more water when salmonids would be migrating up the river to seek out spawning gravels may be a natural pathway over the falls.

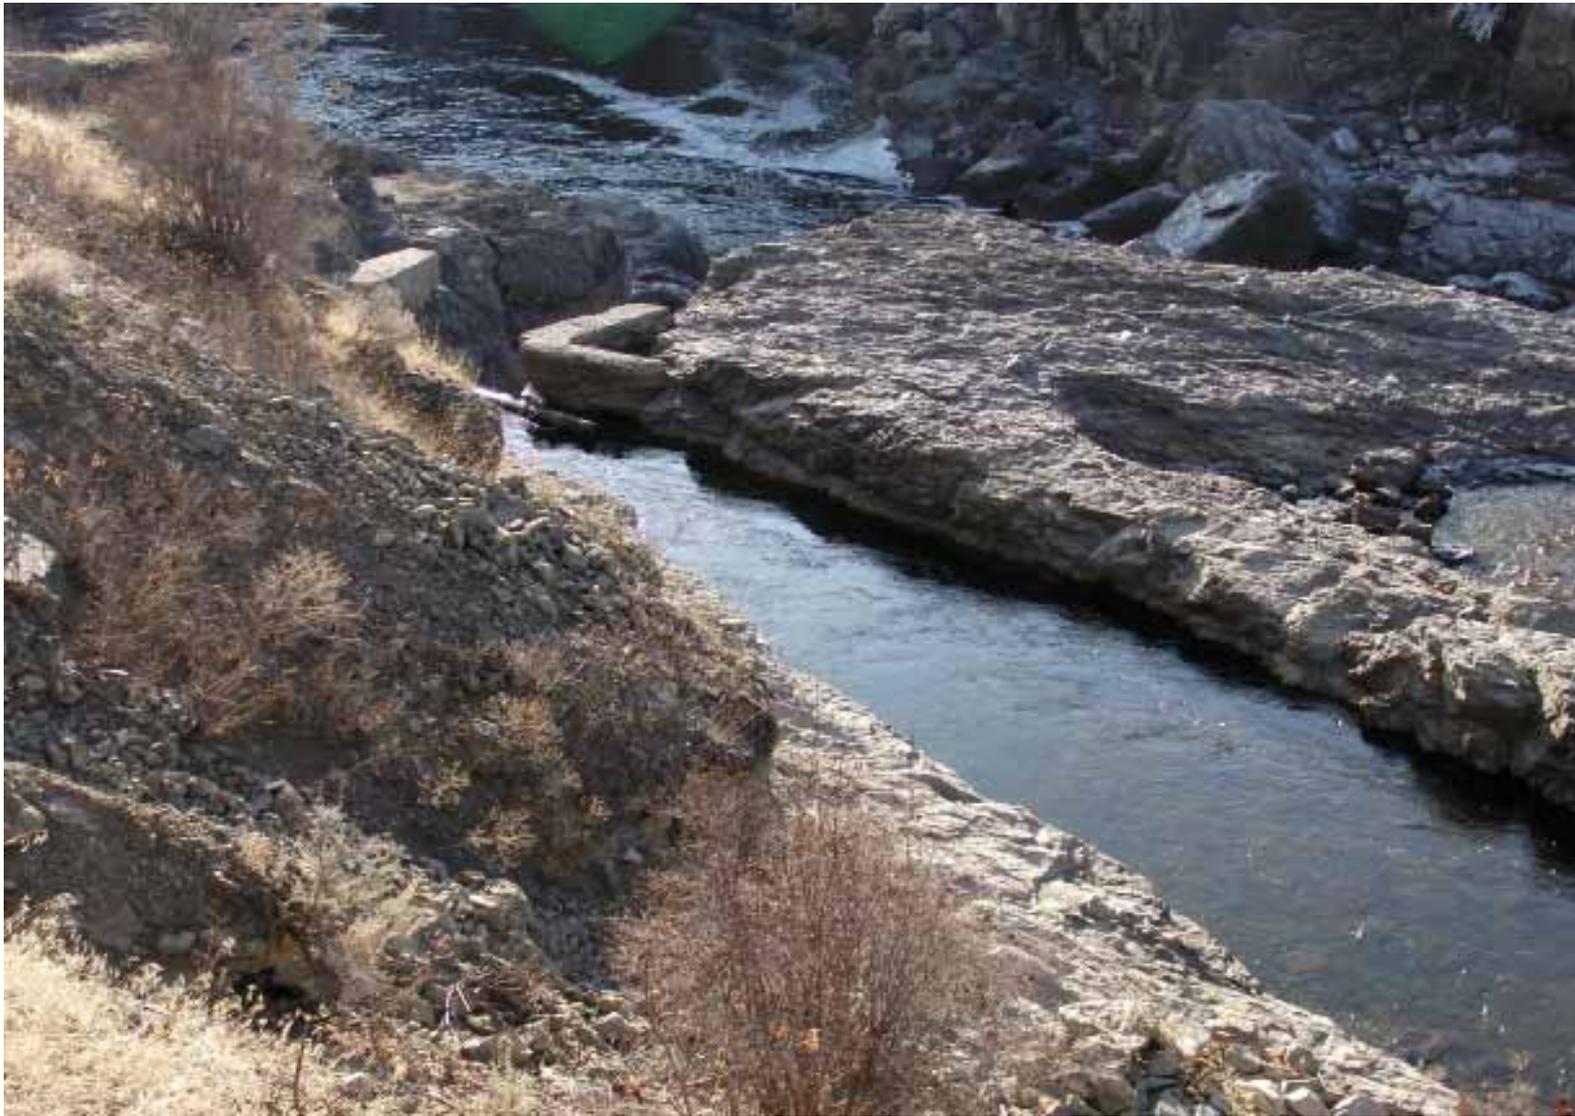
The white water notch in the center of the picture is approximately 6 feet wide. The notch was blasted in the rock wall of the east side of the fall's vertical wall to channel water to the hydro station James Hagerty built in 1906 to generate electricity. The flow returned to the river below the falls. Notice the L-shaped concrete corners that mark the top of the notch, as well as the remnants of concrete foundation remains on the left center where the hydro power house was located

The horizontal channel leading water to the notch was where Hagerty's crib dam must have been located delivering water to his power station.

The main stem of the falls is located to the right of the white water in upper right corner.

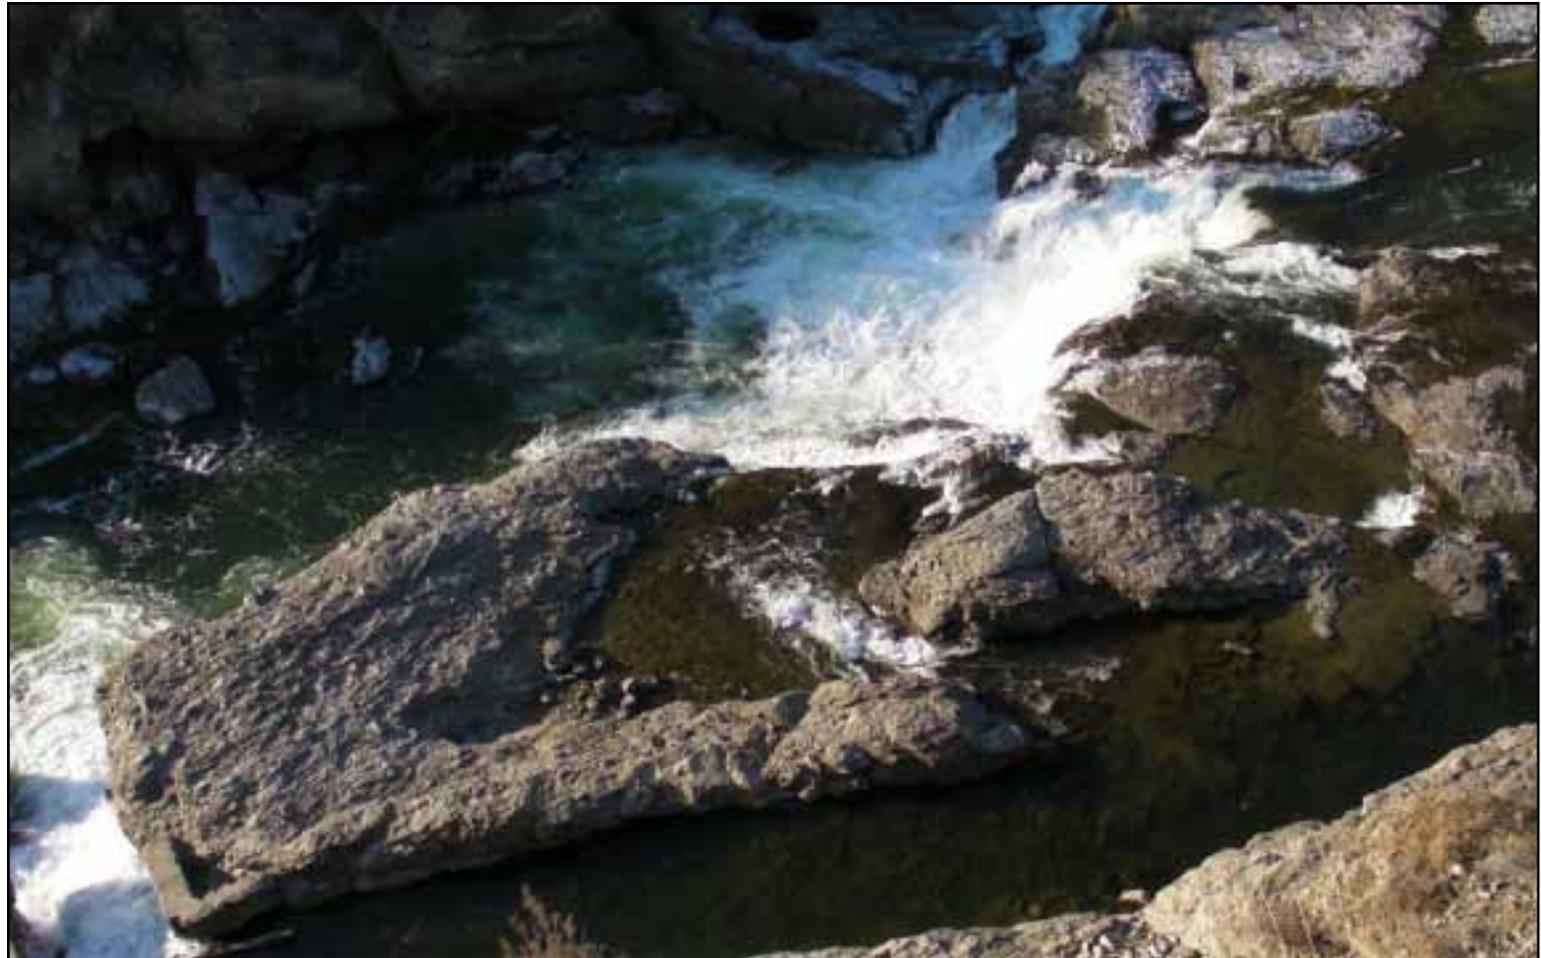
The channel delivering water to the notch visible in the previous picture. Notice the concrete corners at the top of the notch. A log has floated across the top of the notch.

Showing the main stem of the falls, the west side natural channel on upper edge of the picture and the notch in lower left corner with channel along bottom of the picture.

Dale Swedberg, Sinlahekin Wildlife Refuge Ranger, pointed out the necessity of establishing that salmonids would be able to get up over the fall's natural rock wall during times they would be migrating to prospective spawning grounds up river of the falls. He cautions that the notch pathway is not natural and for that reason, can't be considered when addressing the coyote legend.

Dale also pointed out that a salmonid needs a pool of water that is $\frac{2}{3}$ the depth of the a barrier they are trying to clear. The PUD records the fall's rock face to be 30 feet tall which would necessitate a pool's depth beneath it to be 20 feet allowing a steelhead or chinook to propel itself over the falls. However, the amount of water going over the falls during their migration does not present a 30 foot wall since the river's water level is much higher submerging most of the wall's height underwater.
